WELDING PROCEDURE SPECIFICATION

**FOR
52K DWT BULK CARRIER**

Rudder Stock Repair Procedure

Rudder Stock Repair Procedure Specification (RSRPS) No. RBRPS 007

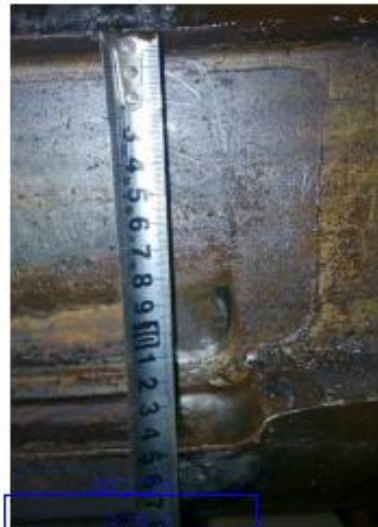
Key way of Rudder Stock and Tiller Damage:

When dismantled the tiller from rudder stock, we noticed the key way of rudder stock and tiller are damaged as per picture indicated.

As per measurement, for each 100mm intervals, the readings are:

Tiller: 138.5, 137.8, 138.3, 138.9, 136;

Rudder Stock: 143, 142.4, 144, 149, 136;

These readings are complied with the ruler on the picture 1 indicated.

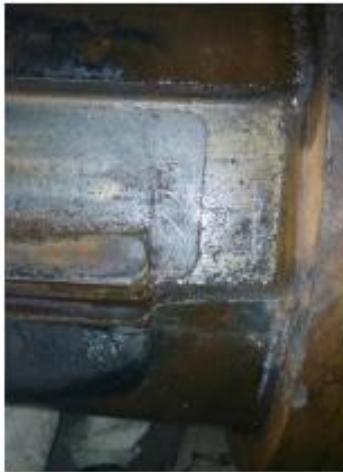
As per sketch, Tiller's Keyway shall be onside is 1:12.5 taper, and another side shall be 1:100 Inclination.

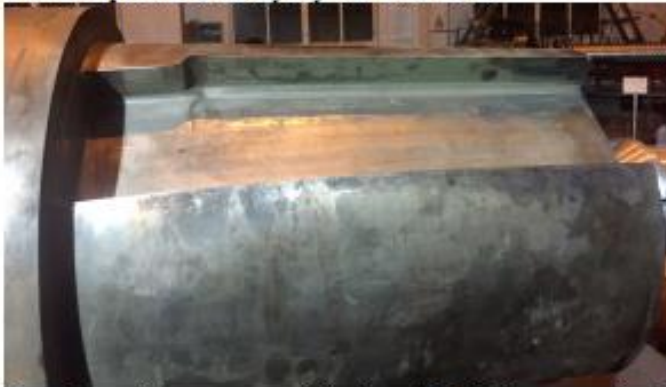
Further to picture of the keyway on rudder stock:

From above picture, we can obviously noticed the keyway seriously deformed. And the readings of the alignment on rudder stock is also confirmed the twisting of keyway.

Since the keyway twisted, then the screw hole on top rudder stock is also changed centering position.

Even though we may delete the misalignment due to this centering hole, we assume the actually misalignment of the tiller cone area is about 2.8mm. In this case, the only repair method is welding. We prepared our welding procedure as bellowing:

After annealing treatment, we will weld 5mm at each single side of the rudder stock, then machining.

Normally as per class's rules, we shall fill up of existing keyway, then make new keyway at 180o opposite position. In order to save time, we will repair the existing keyway by welding, then milling as per request. Since new rudder stock will be bigger, then we may consider to skimming on tiller inner surface to reach a good surface result, then skimming of rudder stock into the same tapping and same size to fulfill blue marking test.
